# Veraview IC5 HD

#### **High Definition Panoramic Imaging**

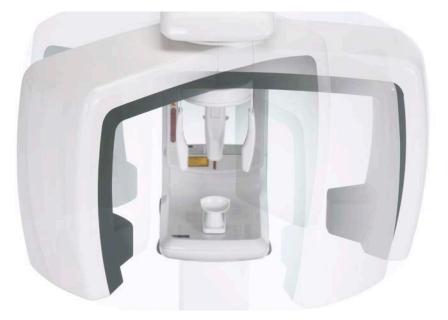
Depending on the diagnostic need, you can take a quick, 5.5 second panoramic for the lowest dose, or a 10 second scan for the ultimate, high resolution image.

#### High Speed

With an industry leading exposure time of 5.5 seconds, the Veraview IC5 is not only significantly faster than conventional film-based panoramic systems, but also requires much less radiation.

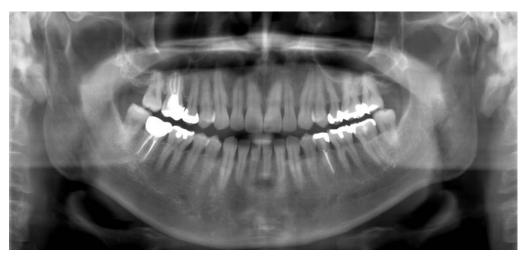
High Speed: only 5.5 seconds, 192 µm, 1/6\*\* X-Ray exposure

High Definition: 10 second exposure, 96 µm

Pixel size is reduced 25% compared with the former model, so it produces superior images of a higher resolution.

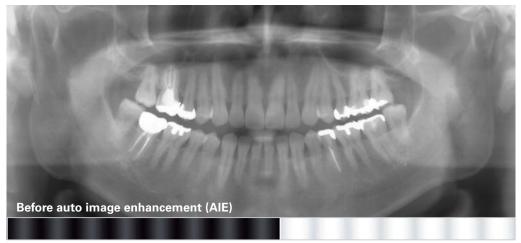
#### **Digital Direct Automatic Exposure (DDAE)**

DDAE controls the X-ray tube current (mA) simultaneously by detecting X-rays passing through the patient. This improves the dynamic range, and, along with Automatic Exposure (AE), results in exceptionally clear images with the best possible contrast and even density. The automatic exposure level can be adjusted to meet your individual requirements.

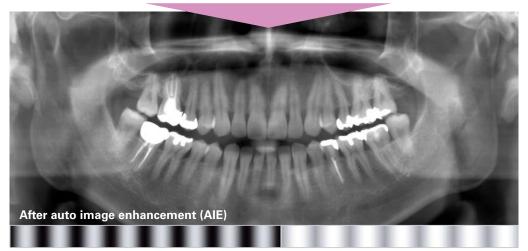
Automatic Image Enhancer comparison

### Automatic Image Enhancer (AIE)

AIE is a special software function that optimizes density throughout an entire image, and highlights the brightness level of detailed areas, to create images with an extremely high degree of clarity. DDAE and AIE perform a logarithmic conversion to produce the highest quality image possible.

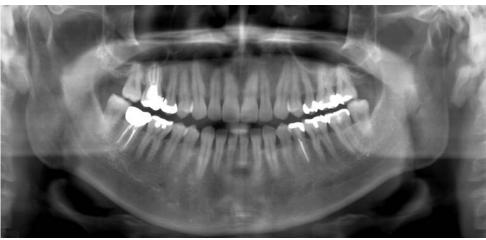
## Panoramic

Clear, sharp images with a wide image layer. The thick, specifically designed image layer accommodates all possible variations of dental arch shapes and sizes to produce extremely clear and sharp images.

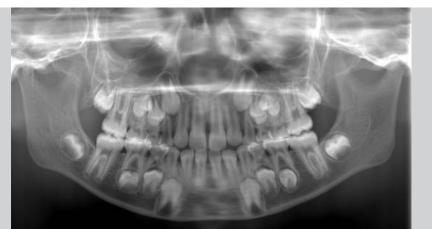
### Pedodontic Panoramic at Reduced Radiation

For examinations of children or people with small jaws, the rotation range of the arm is diminished, thereby further reducing radiation exposure.
